Transmission Facility Outages During the Northeast Snowstorm of October 29–30, 2011

Causes and Recommendations

Prepared by the Staffs of the
Federal Energy Regulatory Commission *and* the North American Electric Reliability Corporation

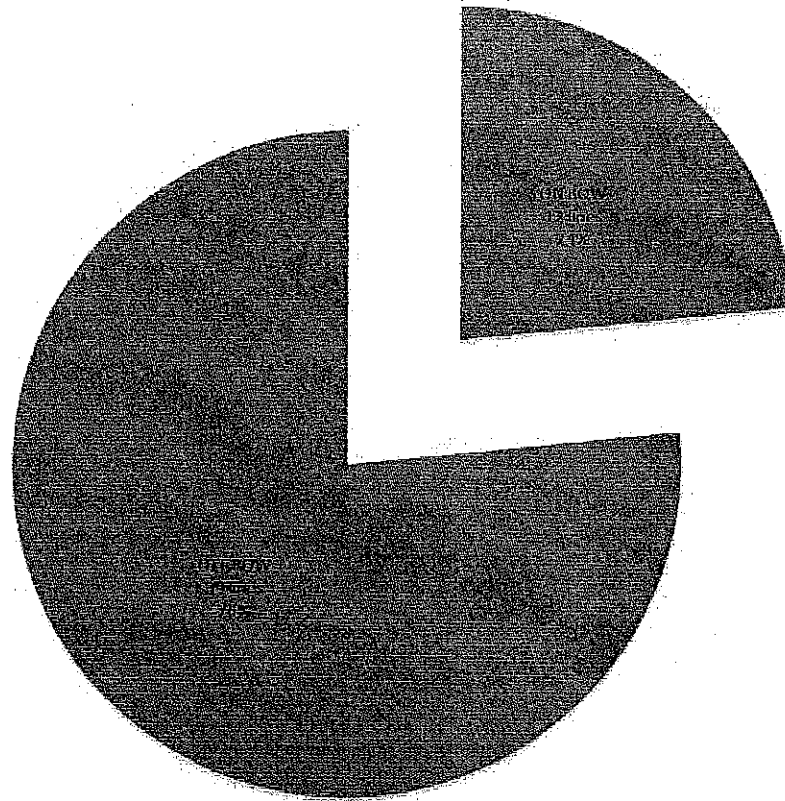
Figure 12: Fallen Trees Located on Rights-of-Way and Off-Rights-of-Way

The 115 kV line in the photograph below was forced out of service when several trees, each over sixty feet tall and located twenty to thirty feet outside of the utility's full right-of-way, uprooted and fell onto three separate spans of the line. Transmission lines are not always located in the middle of a right-of-way, but instead often are closer to an edge of the right-of-way. Thus, as is the case here, a tree may be outside the boundaries of a 130 foot wide right-of-way but still less than sixty-five feet from a conductor.
